DO YOU TRUST YOUR AS BUILT?

Frederick R. Holley | Circuit Rider III

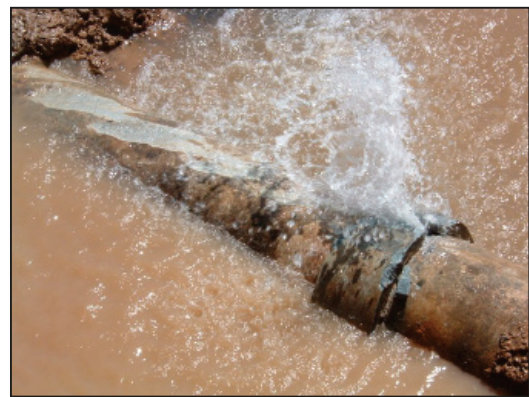
A year later, the project finally broke ground. Utilities were marked and those in the way were relocated or just exposed to verify the depth. About 2 weeks into the project, I was shocked to get a panic call from the county workers that they had water shooting 20' into the air. They weren't even supposed to be near

the main.

Checking the excavation, we determined that the as built was 30" off. How could that be? It was an as built therefore it was gospel. I guess not. The main was relocated putting a strain on our budget.
