## SOURCE WATER MAINTENANCE: A LOOK INTO HOW A MUNICIPALITY IS PRESERVING THEIR INFRASTRUCTURE

Molly Reed | Training Specialist

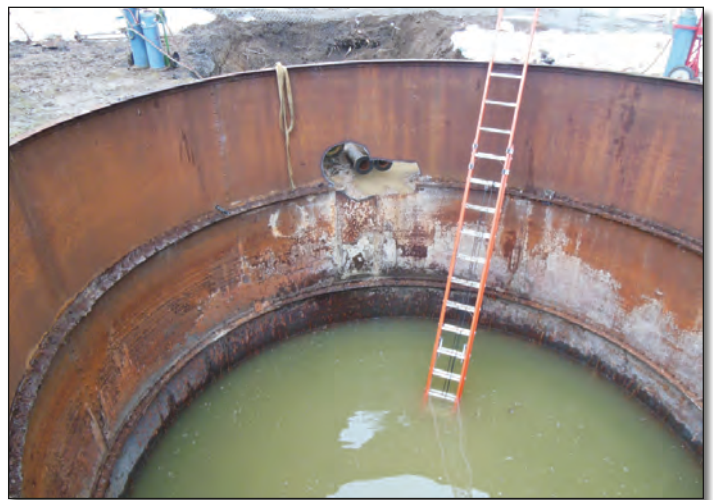
**Original Well Casing with Suction Lines Removed**

Preparation and planning for the project began in 2013. The Village retained a consultant to determine the structural integrity of the well. A remotely controlled submersible camera was used to view the interior of the well. This inspection revealed excessive pitting and corrosion of the well casing. The Village’s engineer, Steve Darcangelo, reported these findings to the Village Board of Trustees and recommended a project to reinforce the casing to preserve the well. With Board approval, Steve initiated a project to retrofit the well.

After weeks of adjusting pump speeds and analyzing flow demands, the well was shut down, suction piping removed, and the first components were placed in the well. The first lift consisted of the three lower sections of new casing. After those sections were set in place, leveled and shimmed, the top section was set in the well and bolted in place. This lift consisted of the two top sections of the casing, the mezzanine legs and the mezzanine framework.

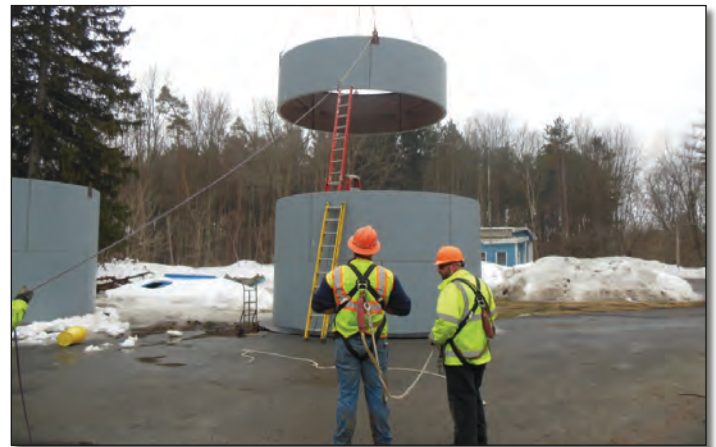
**Lower Three Well Casing Sections Being Assembled**

In the fall of 2014, the Village ordered the new casing. It was constructed of 3/8” steel and was shipped in 25 pieces. Five pieces make up one five-foot tall ring. The new well casing was designed to be placed inside the existing 20 foot well. The space between the new and old casing would be filled with concrete to improve structural support.

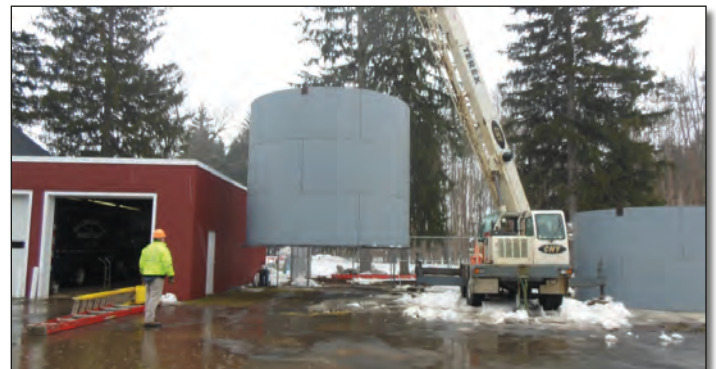
**Lower Three Casing Sections Being Lifted into Place**

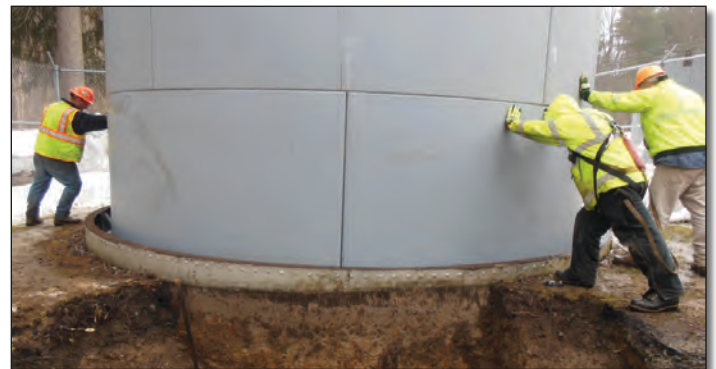
**Lower Three Casing Sections Being Set Into Well**

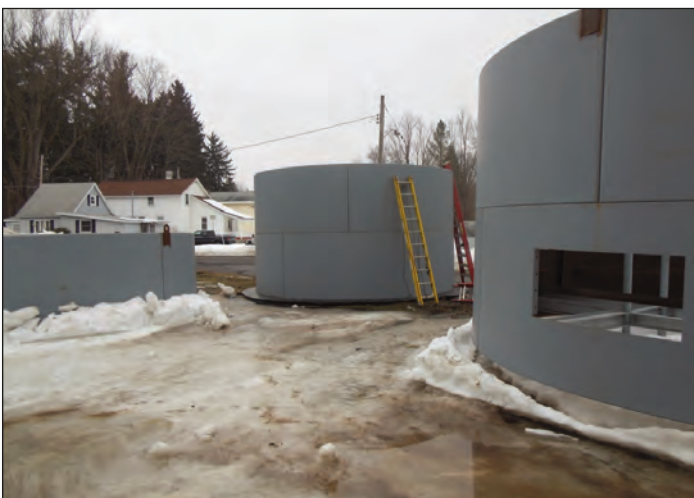
**New Well Casings Assembled and Ready for Installation**

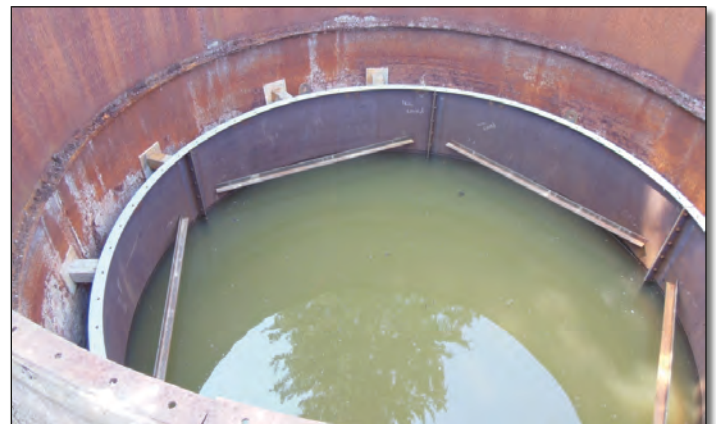
**Lower Three Well Casing Sections Set In Place and Shimmed**

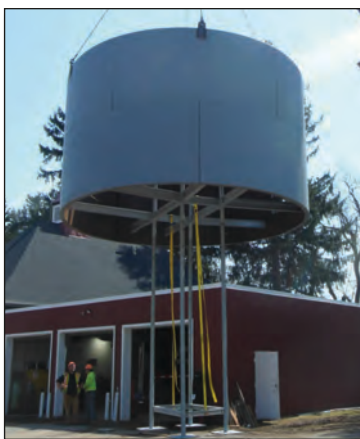
Upper Two Casing Sections,  
Mezzanine Legs and  
Mezzanine Frame Being  
Readied for Installation

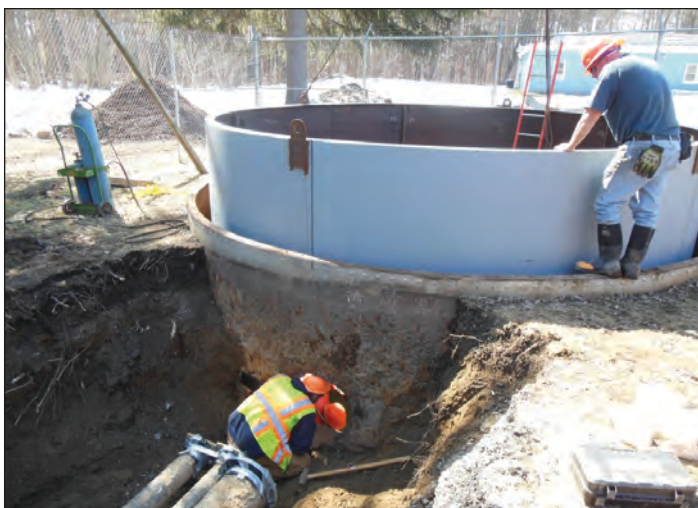
Well Casing Sections In Place and Being Bolted Together

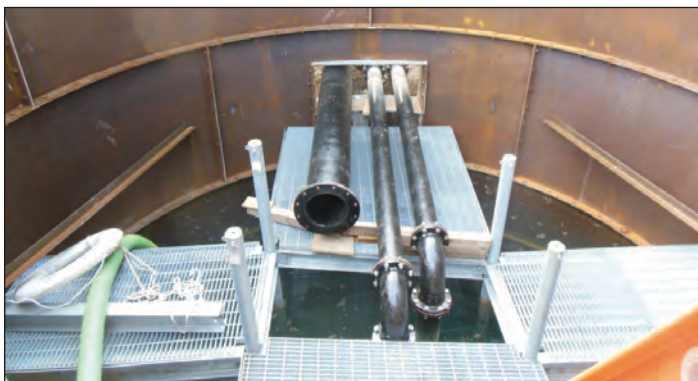
Interior of Well Showing Suction Piping and Mezzanine

In February 2015, the members of the Village of Baldwinsville Department of Public Works began assembly of the well casing, cover, and mezzanine. The mezzanine was constructed inside the

well just below suction piping in an effort to improve access and accommodate future operation and maintenance.

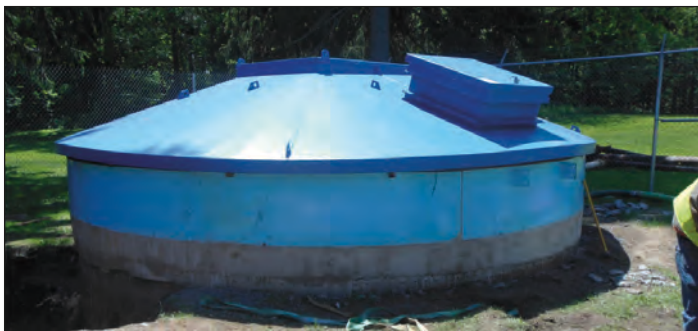
Completed Well Retrofit

The condition of well piping and valves were examined and the Village determined to replace these components at this time. Once all necessary parts were replaced, the cover was placed on the well. The well was shock-chlorinated for a period of 24 hours. A series of samples were then collected from the well and results were submitted to the County Health Department. Following Health Department approval, the well was placed back on line.
