## TO LINE OR NOT TO LINE, THAT IS THE QUESTION.

Frederick R. Holley | Circuit Rider

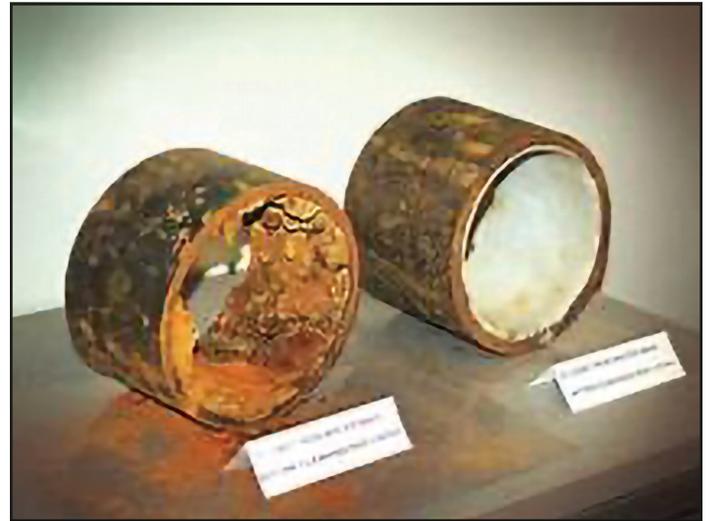
In my home system fire flow calculations were done to help determine the extent of tuberculation. A dead-end hydrant, on a 6-inch CIP main, gave us a maximum flow of 250 gpm. A spot was chosen, and a profile section of pipe was examined, our 6-inch pipe looked more like a very rough 4-inch pipe on the inside. Specs were written, bids were submitted, and a contractor was chosen. The water department was to install and maintain all of the temporary piping and connections and do all of the excavation and restoration. The main was scoured, swabbed, then a camera was run through, after which the lining began. A grout trowel was pulled through from section to section. After curing, each individual curb stop was opened to remove the grout from the corp. When done, the tee's, valves, and hydrants were all replaced.

The main was chlorinated, flushed and sampled before going back in service. A follow up fire flow was done, and the same dead-end hydrant would now flow 900 gpm.
