INSPIRATION FROM PERSPIRATION AND HARD WORK ETHICS

Yvonne Tucker | Wastewater Trainer/ Technician

The Village of Akron is located in Erie County, N.Y. Originally conceived of and built in the late 1920s in response to the Village being stricken with a typhoid epidemic. A major upgrade was initiated in 1965, and again in the 1980s. The current facility consists of a comminutor and grit channel, a flow equalization tank and primary clarifier, rotating biological contactors, a secondary clarifier, tertiary sand media traveling bridge filters, and anaerobic digestion with covered drying beds. In 2014, the Village opted to resume full-time responsibility for the operation and maintenance of the wastewater treatment plant by not renewing a 10 year long contract operations agreement. Mr. Bob Lucia, a 17 year employee with the Village, had obtained his grade 2 wastewater certification in 2002. He has always maintained his renewal contact hours even though his job duties were in the collection system and not at the treatment plant, since that was covered by the contract operational firm. His son, Robert Lucia Jr. came to work for the Village in 2001, as a part-time, summer worker. Togethe

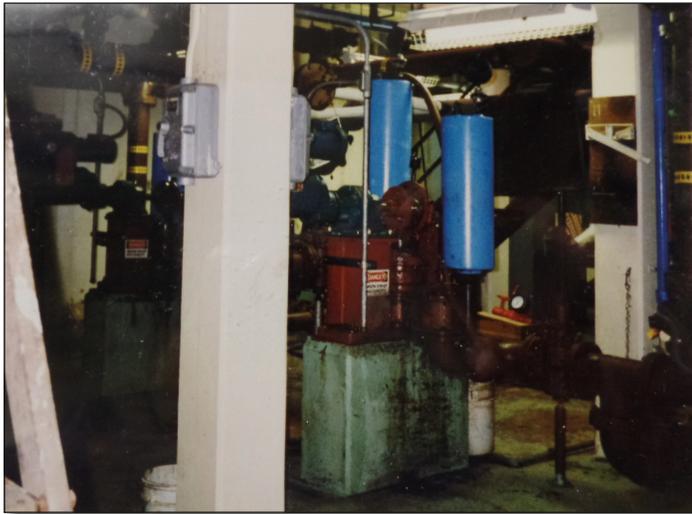
Due to the many years of corrosive conditions and the aggressive nature of the material being pumped and transferred, the basement of the anaerobic digesters was in deplorable condition. Sludge pumps were in need of replacement, valves

were corroded, broken, or frozen and or difficult to operate. A valve exercise program was immediately initiated. Two of the sludge transfer pumps were replaced with Volgesang positive displacement pumps. Poor lighting, peeling paint, wet floor from leaking pumps, and sludge stained ceiling and walls created a damp, dark, and generally a just unpleasant area. Bob and Robert set about putting some serious elbow grease into this part of the treatment plant. An area of the facility, few are ever even aware of, let alone encouraged to visit. After stripping all the peeling paint from the concrete and the metal piping system, they primed and painted floors to ceiling, every inch of the lower level. Robert recalls the many hours of scraping and cleaning that went into just preparing for the painting. A lot of work went into cleaning up the polymer make-down and feed system which was completely gooped-up with several inches of “years of polymer” buildup. The

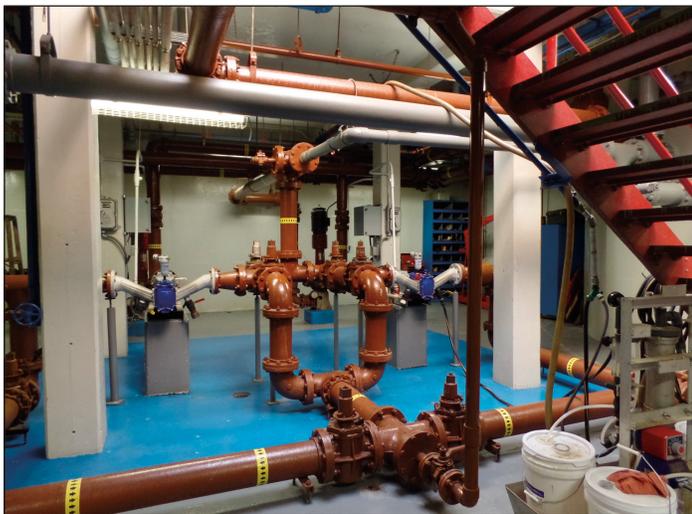
unit now looks like it was set in place a month ago.

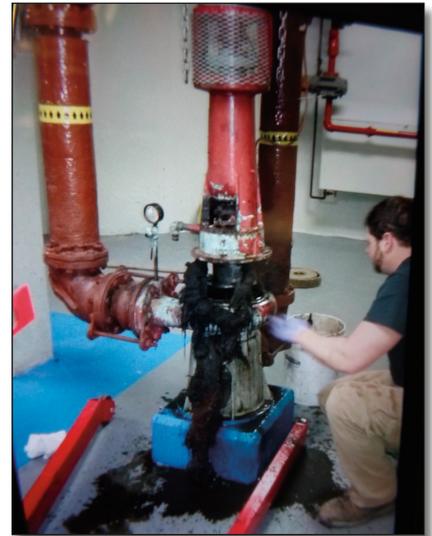
Entering this basement area today reveals a brightly lit, completely clean, ceiling, walls, and floor pump gallery. All the piping is freshly painted, color coded, and protected from further external corrosion. A workbench with every tool necessary to work on each pump, valve, and polymer make-down system

is neatly organized and ready for every work activity that might arise. The floor is kept dust mopped routinely, and wet mopped when necessary. This 50+ year old space and equipment has the appearance of a facility that might have been built in the last five years due to Bob and Robert’s hard work and attention to detail. Having to unclog a pump due to “ragging” and hair ropes creates a mess. However the area is completely cleaned and all traces of the work are washed away.

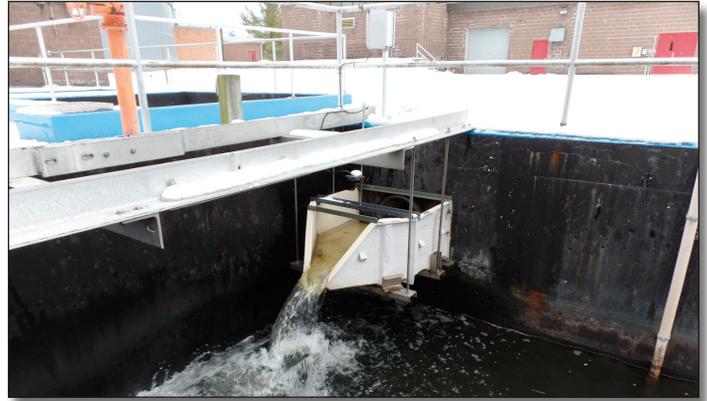
equipment that they are responsible for is apparent throughout the facility. The results of their efforts and attention to detail can be seen everywhere you look, from the brilliant red, painted exterior doors to the sky blue concrete surrounding the grit channel and primary clarifier. Done right, the painting is not just an exercise in creating attractive structures, it is a fundamental procedure to protect and preserve the equipment, the pipes, and the concrete from the harsh environmental conditions that exist in wastewater treatment. To describe what I see when I enter the wastewater treatment plant as I have attempted in this article is truly inspirational. With just the two of them to operate and maintain the wastewater treatment plant, the collection system, two lift stations and, as time allows, provide service to neighboring communities, they are to be commended. They endeavor to create a pleasing work environment, where they work collaboratively and energetically and yet so effortlessly in a relaxed environment. They truly set the bar high, and they show up for work every day with the desire to not
