ASSOCIATE MEMBER SPOTLIGHT

PRODUCTIVITY AND EFFICIENCY IMPROVEMENTS IN WATER PLANTS BY RETROFITTING MODERN AUTOMATION.

Chris Warnett | V.P. Engineering at Upstate Valve and Control

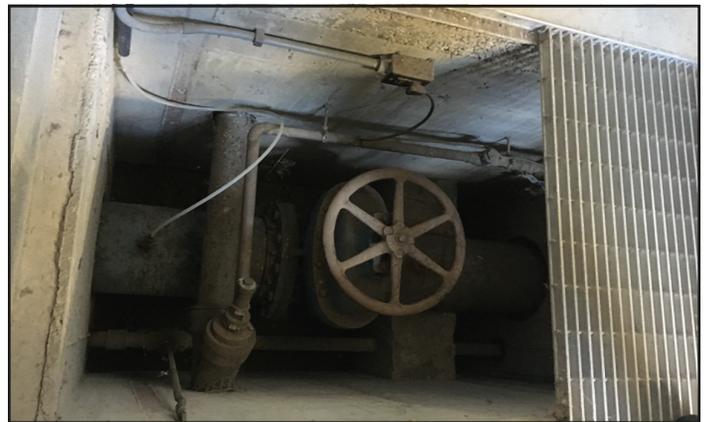
Isolation valve in pit, showing manual hand wheel.

A water filtration plant at the Finger Lakes was such an application. Their isolation valve was below grade and in order to operate the valve, a grating had to be removed and the plant operator was required to climb into the shallow valve pit and turn the hand wheel. This was time consuming, and caused the passageway to be blocked during the operation.

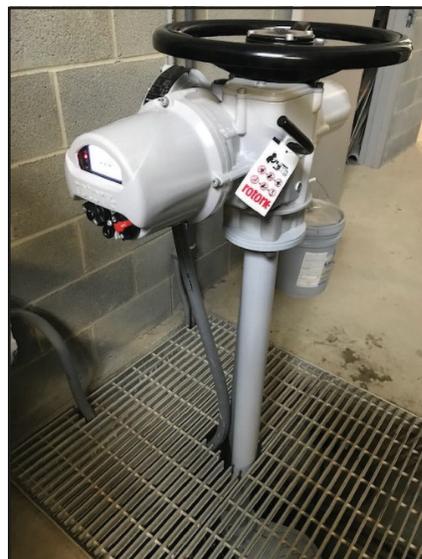
Electric actuator, pedestal. mounted

The solution was to automate the valve with an electric multi-

turn actuator mounted at grade level, driving a spur gearbox that was adapted to fit the valve using a retrofitted power flange and new stem. After initial measurements were taken and consultation with the valve maker, UVC designed and fabricated the valve adaption and extension pedestal to position the actuator at a convenient grade level. The offset of the gear on the valve allowed a clear path in the passageway.

This solution allowed both local and remote operation without disruption of the working environment. The valve can now be operated conveniently and quickly.

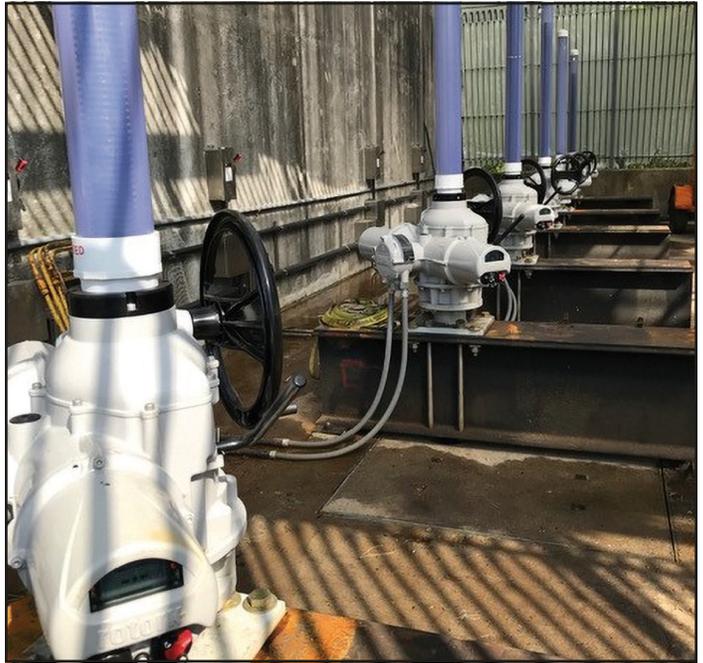
New electric actuators.

One viable solution is to replace the old hydraulic cylinders with new electric actuators. There are many advantages to this retrofit, not only the reduction in maintenance hours required but also the improved gate protection afforded by the actuator diagnostics.

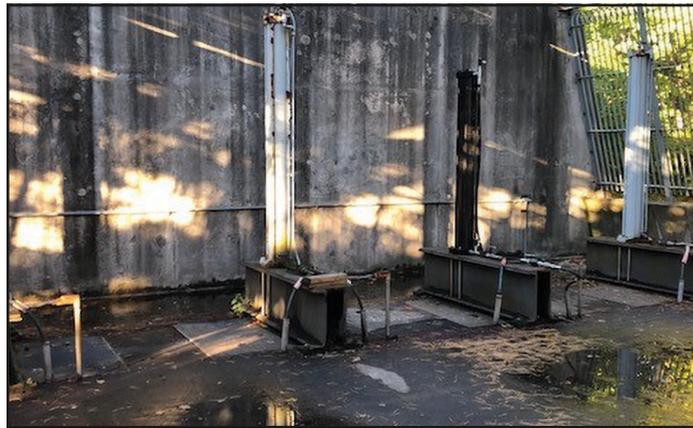
Old hydraulic cylinder actuators.

There are many sluice gates in the NY rural area that have been in operation for some time. The gates themselves are usually robust and functioning as designed. However there are many hydraulic actuators with central hydraulic power units on these gates that are now obsolete and difficult to maintain or repair.

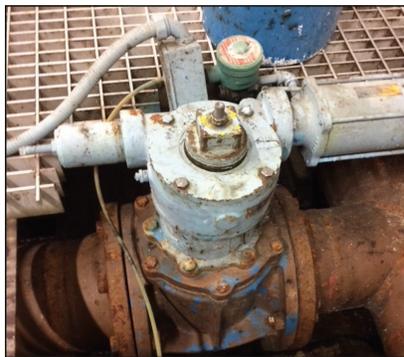
Old pneumatic actuator at floor level.

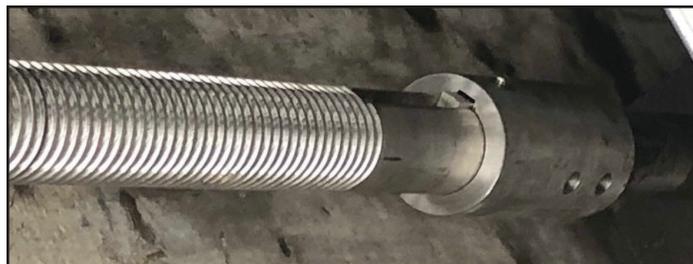
Replacement threaded stem.

The actual retrofit operation requires the hydraulic cylinder and piston rod to be replaced with a new threaded stem and electric operator. Care has to be taken to ensure there is proper constraint to prevent the stem rotating under the action of the rotating stem nut of the actuator. This can be achieved by replacing the thrust collar in the gate pocket with a thrust nut. Alternatively the new stem can be machined with a long key slot. A mating key, mounted in a special torque plate, runs in the slot to prevent stem rotation.

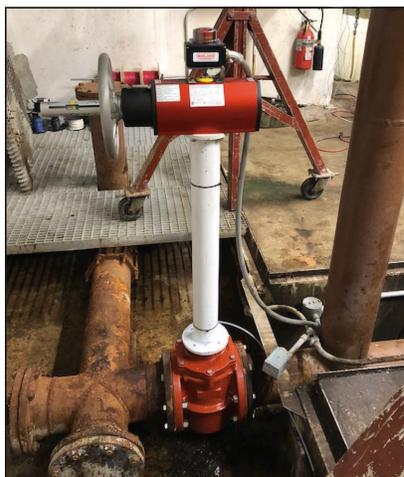
New pneumatic actuator on pedestal for easy access.
