# SMOKE TESTING THE VILLAGE OF OAKFIELD

Yvonne Tucker | Wastewater Trainer/ Technician

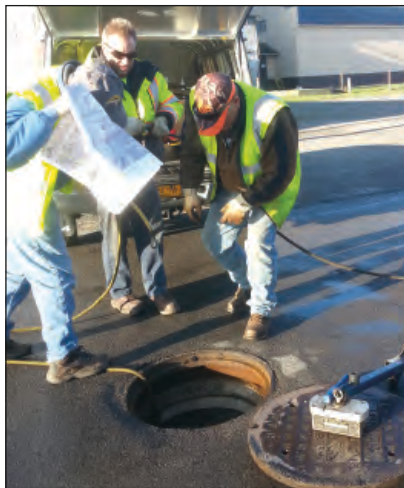
In the picture at right you might have noticed the blue device that the Village of Oakfield owns for lifting manhole covers. It is called a Magswitch Manhole Cover Lifting System. It consists of one Magswitch Lifting Magnet and one Magswitch Mag Dolly. Using the Manhole Cover Lifting System was a cinch. I just had to get in on the fun.
