TANKS A LOT!

Douglas R. Smorol | Circuit Rider II

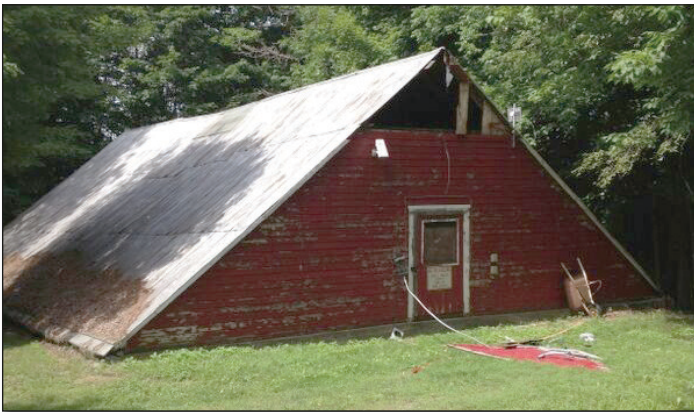
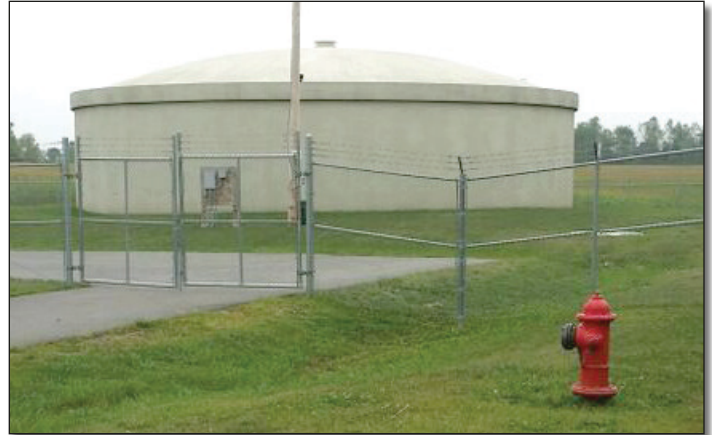
Almost twenty years with the New York Rural Water Association and in that time I have had the opportunity to view, photograph, inspect, and climb a variety of different water storage vessels. Each and every one has a unique character and location all its own. For this article, I would like to share a few photos I have taken over the years. The first tank I would like to share with you was located in South New Berlin, NY. It was a laid stone and mortar in-ground tank with a wooden barn roof built over it. I would have to guess the capacity of this tank at about 50,000 gallons. This tank no longer exists as it was replaced with a Aquastore tank a few years back.

so in order to find enough natural elevation it was located on a rise about a half mile outside the village.

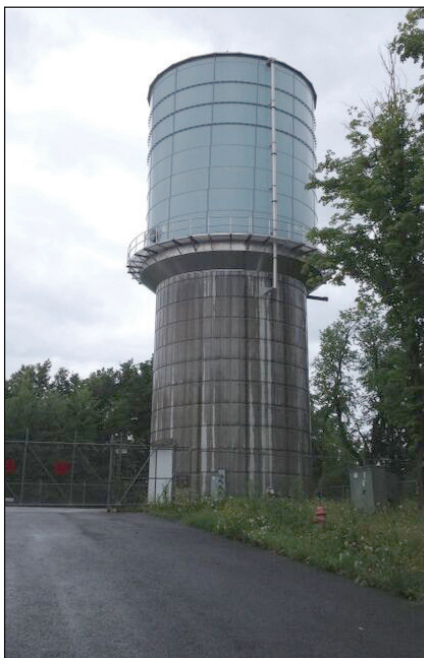
This tank was completed the year I came to work for NYRWA. Located in the Village of Cherry Valley, NY, it is a 300,000 gallon concrete, cast-in-place tank. What makes it unique is that it is divided into separate 150,000 gallon tanks. Located on a hill inside the village, it has been piped and valved so that both sides can be in service or one side can be in service and the other valved off for inspection, cleaning, repairs, etc.

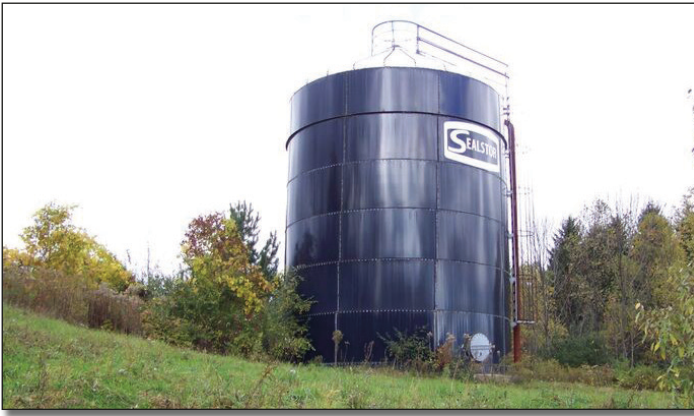
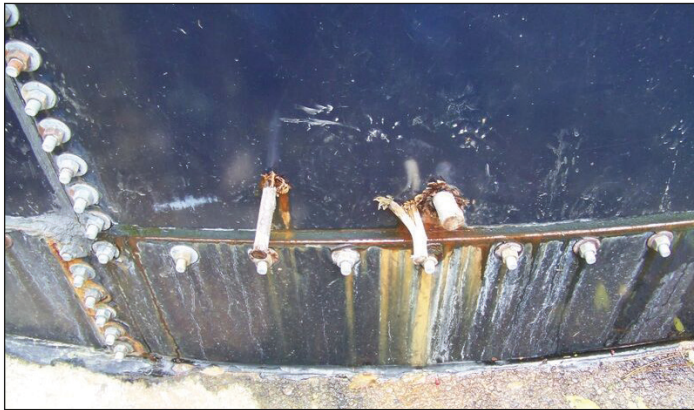
The next tank was a Sealstore Tank (early 80's) about 120,000 gallons located in the Hamlet of Erieville, NY. This tank served the district well until 2013 when corrosion finally took its toll on this early design. The second photo shows the operator's attempts at plugging the leaks by sharpening pieces of nearby underbrush and pounding them into the holes. This tank was replaced by a new Aquastore tank in 2014.

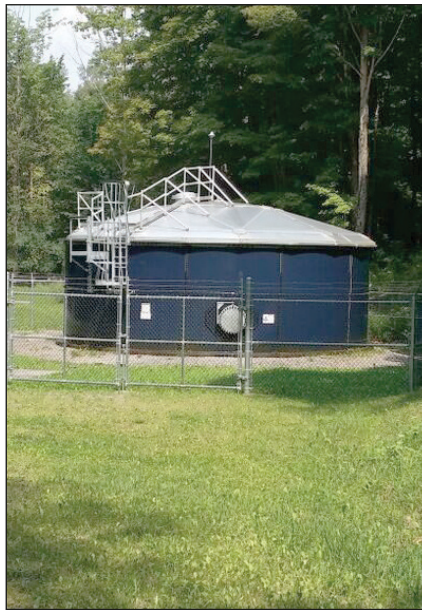
The last tank I will share with you in this article is also the smallest. Located in the Town of Paris, NY, it is a 45,000 gallon Aquastore tank that was built at the source to provide adequate contact time for customers that were connected to the original untreated source. This tank, the wells and treatment plant were completed in 2007.
